ROPE A NEW PERSPECTIVE ON RISK MANAGEMENT THROUGH LINE MAINTENANCE AND SELECTION

TANKER OPERATOR CONFERENCE MAY 10TH ATHENS

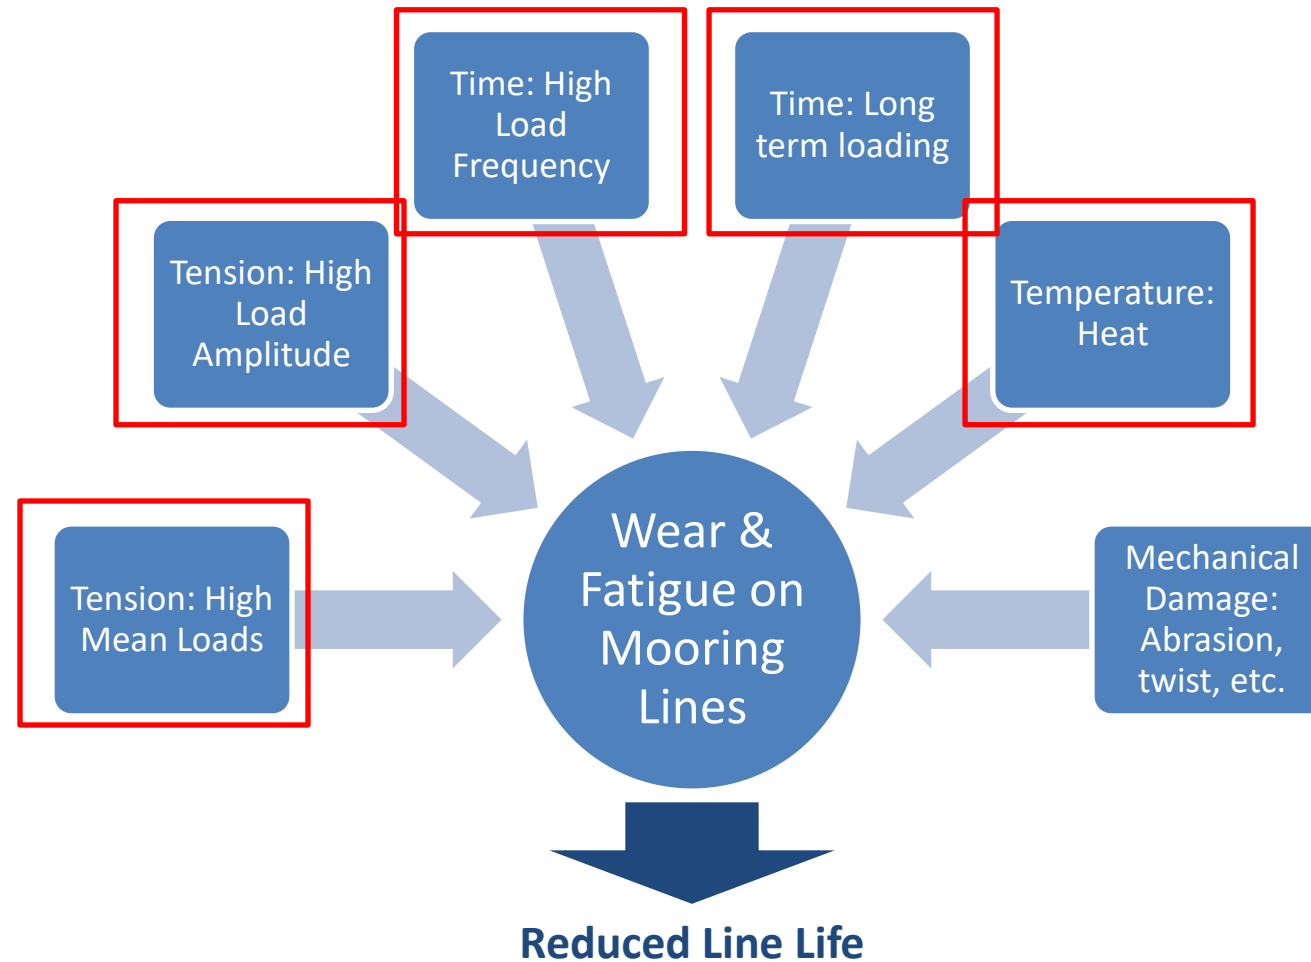
Mooring line damage is accelerated with high loads, high load frequency and high ambient temperatures.

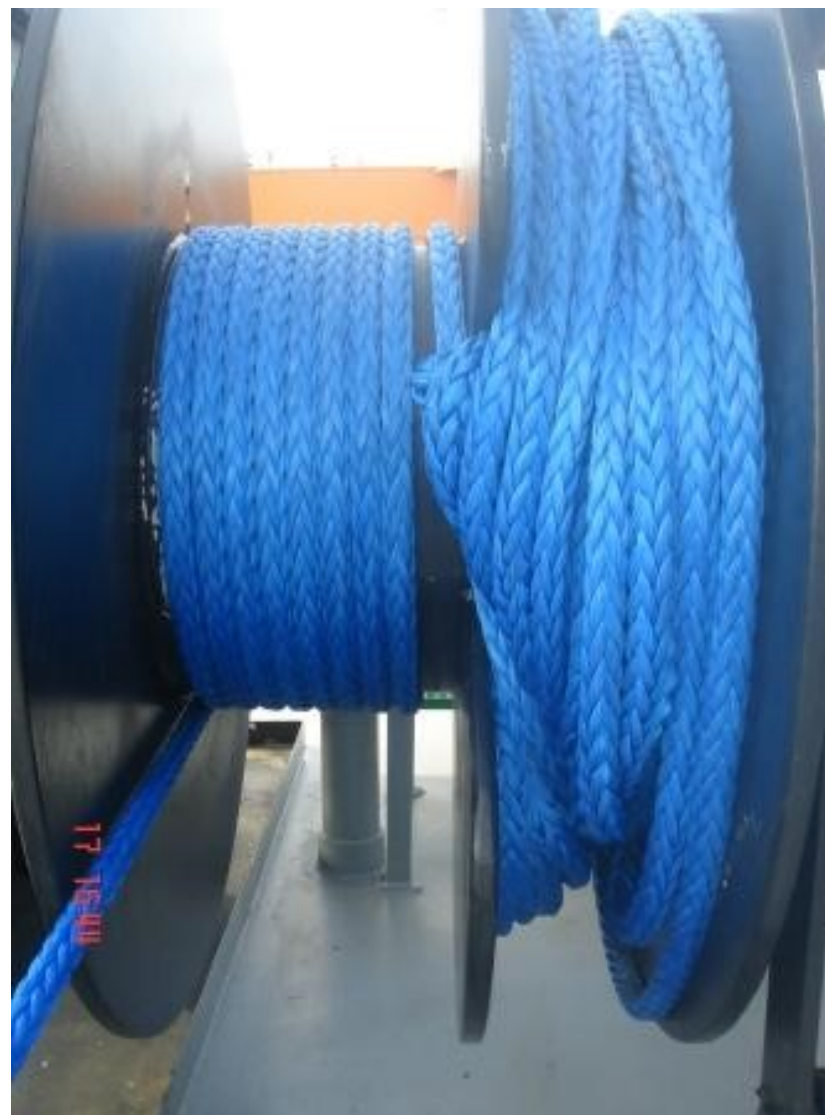
INSUFFICIENT WRAPS HAZZARD

Insufficient wraps will lead to the ropes slipping on the drum.

- This will generate heat and damage the rope fibres.
- In severe cases, this damage will appear as a dark coloured, hard glazed area on the rope

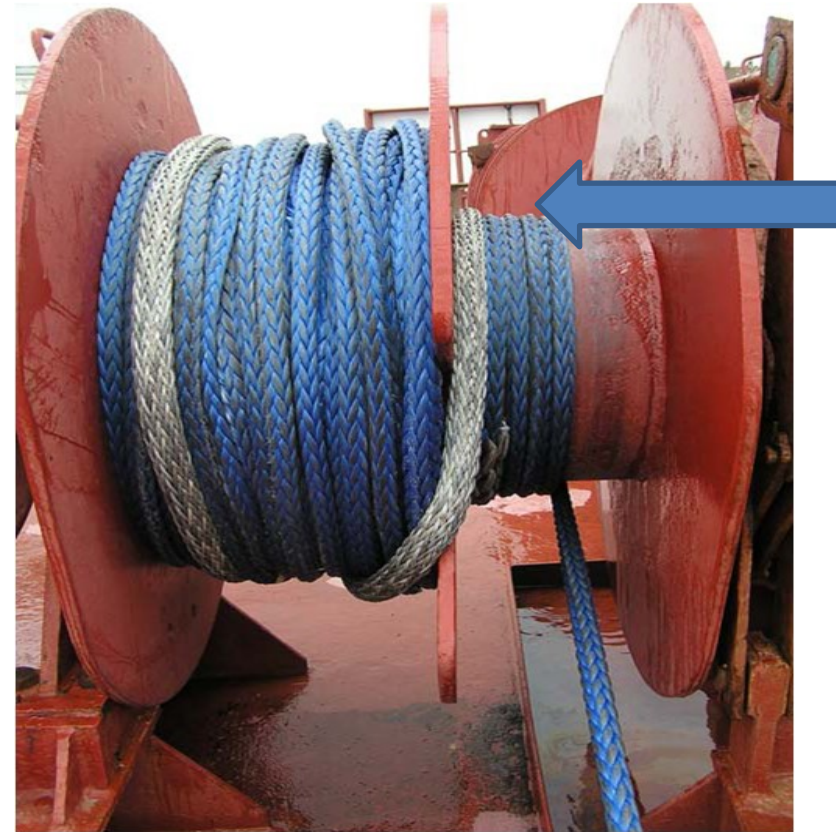
INSTALL OR RE INSTALL WITH TENSION

It is extremely important to install Samson's synthetic mooring lines with the recommended 45-90kgs of back tension.

If lines are not tensioned while being installed the risk of damaging the lines when high loads are experienced increases.

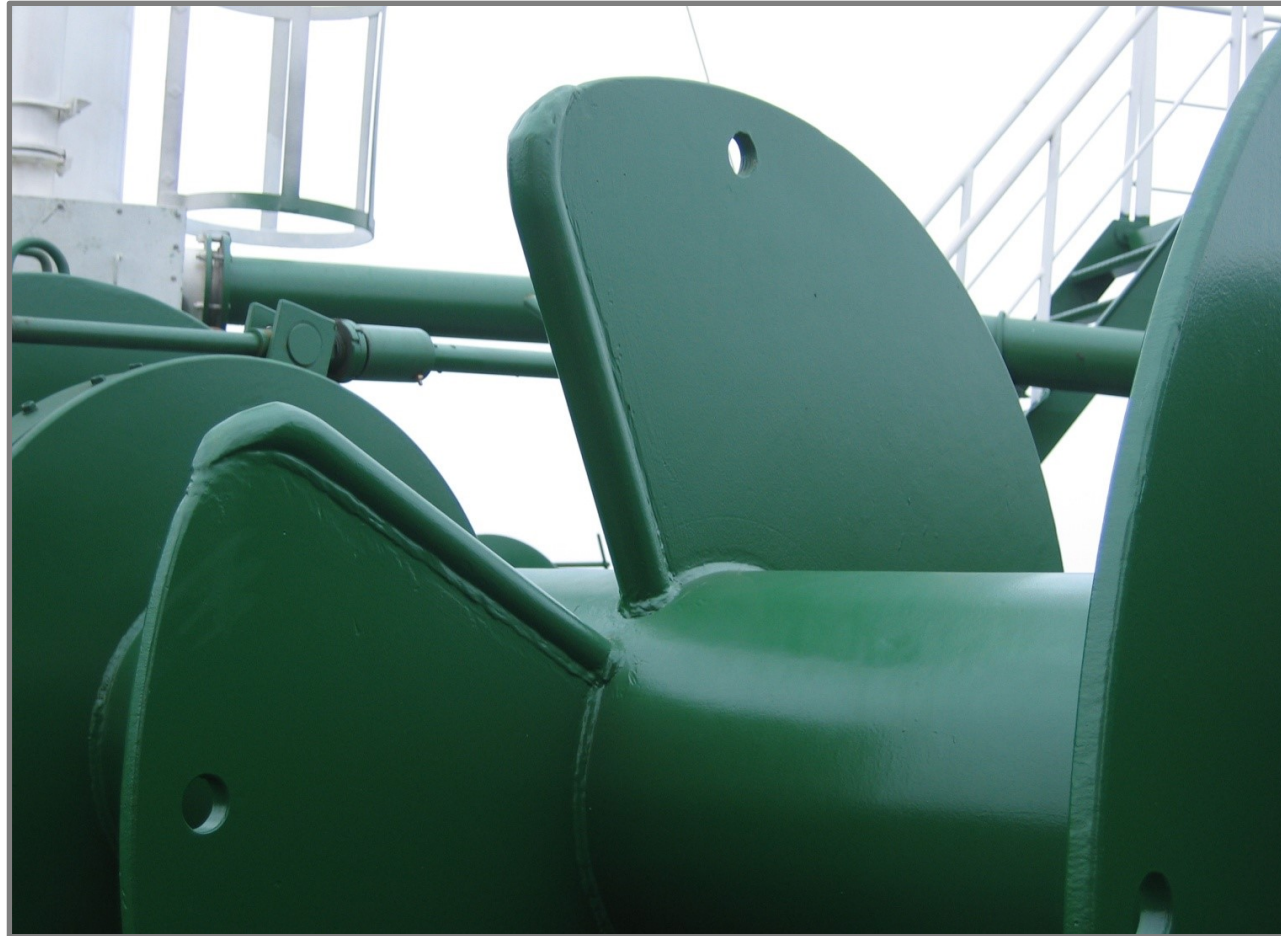
When circumstances allow it, the retrofitting of the leading edge of the dividing plate profile should be 40-50 mm in diameter.

- Inspect all surfaces prior to installing new rope
 - ***Rough cast surfaces / sharp machined edges***
- Synthetic rope life decreases when contacting sharp edges / rough surfaces
 - ***Maintain contact surface roughness less than 300 micro inch RMS***
 - ***Radius sharp edges to 2mm or greater***
 - ***Key Locations are:***
 - *Panama/Roller leads*
 - *Capstans*
 - *Inside of Winch flanges*
 - *Dividing plate*

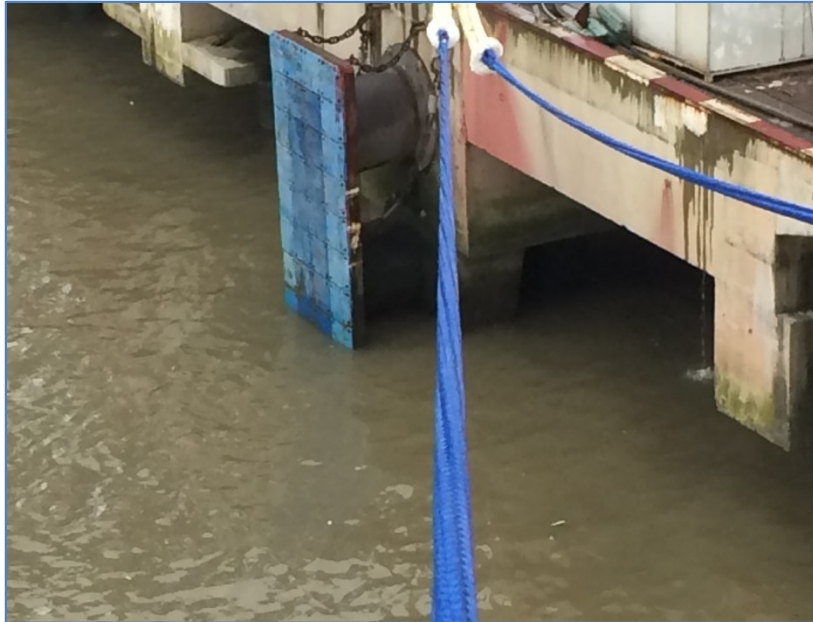
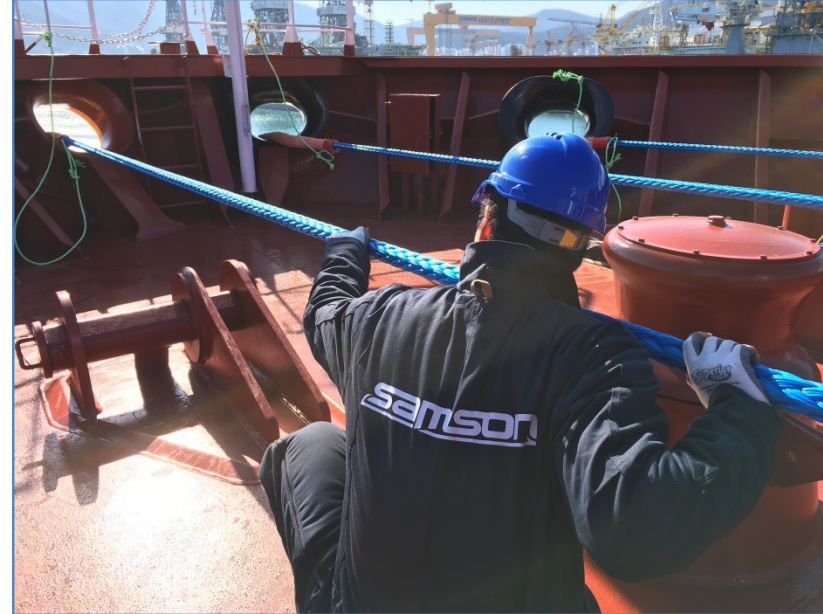
If a 3-strand messenger line is used during the installation, there is a high probability that the twist from the 3-strand will transfer into the torque neutral 12-strand Samson line.

Samson's 12-strand lines are torque neutral, twist that is induced into the constructions will actually temporarily decrease the strength. At 3 twist per meter, the strength is decreased by 10%. If twist is induced during installation, **remove** before berthing.

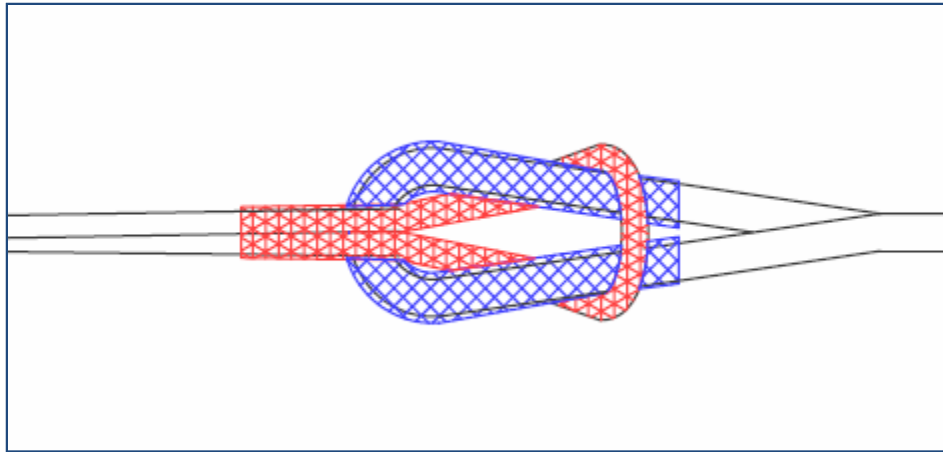
CONNECTION MECHANISM

A Cow-Hitch should be utilized when connecting the mooring mainline to the mooring tail.

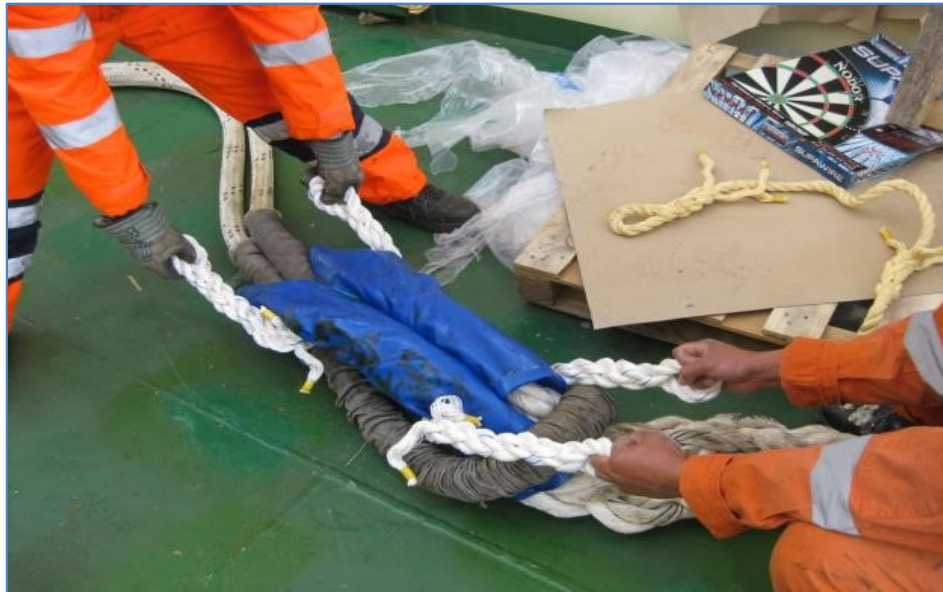
It is recommended to use smaller diameter synthetic lines in-between the eyes of the mainline and tail. This will dramatically help when it comes time to separate the two.

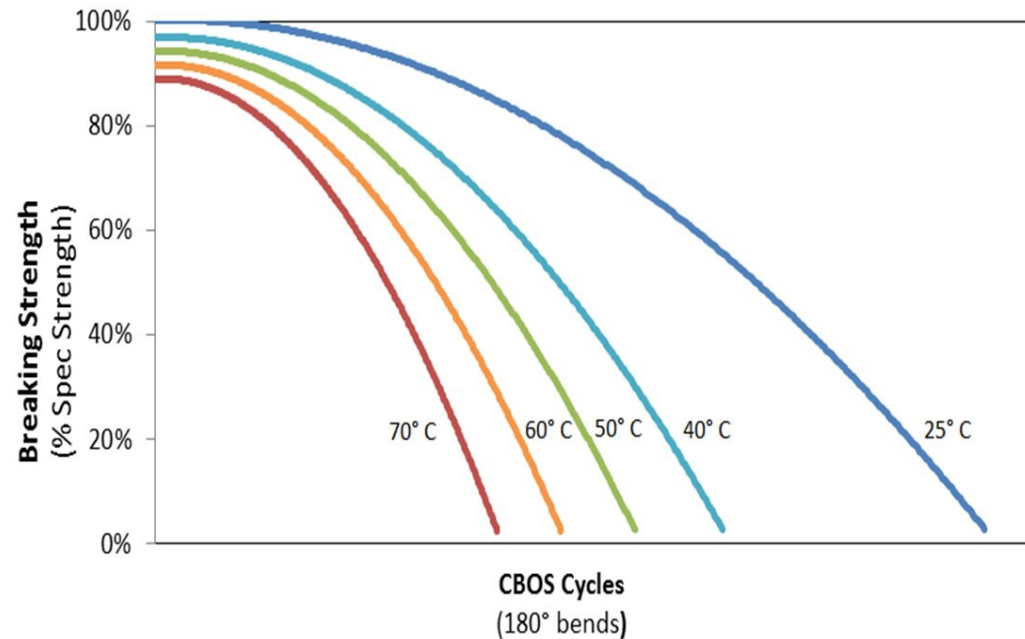
Cyclic bend fatigue combines external and internal abrasion, and can also generate temperatures capable of damaging fibers

- **Best practices to mitigate impact:**
 - ***Maximize D/d ratios***
 - ***Select appropriate fibers, coatings, rope constructions, and safety factors***

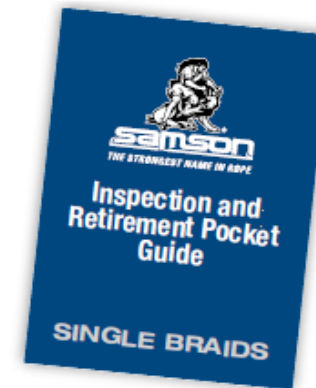
The Pocket Guide includes information on proper rope inspection techniques and a visual guide to internal and external abrasion

- Visual comparison guide
 - **1 million+ individual filaments per rope**
 - **Operator can effectively rate level of rope wear**
- Retirement or required action to be determined by qualified person based on the following:
 - **Internal/External abrasion level (higher than 3)**
 - **Excessive twist in braided rope (greater than 2 turns/meter)**
 - **Gross damage or deterioration of the end connections**

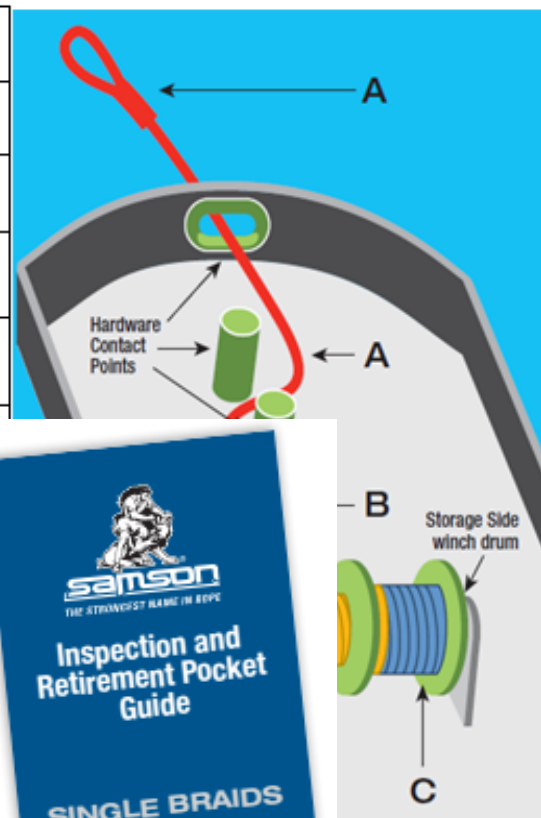
Mooring Line Inspection Sheet

- Crew-performed inspections with data managed by Samson and reports accessed through Partner Portal

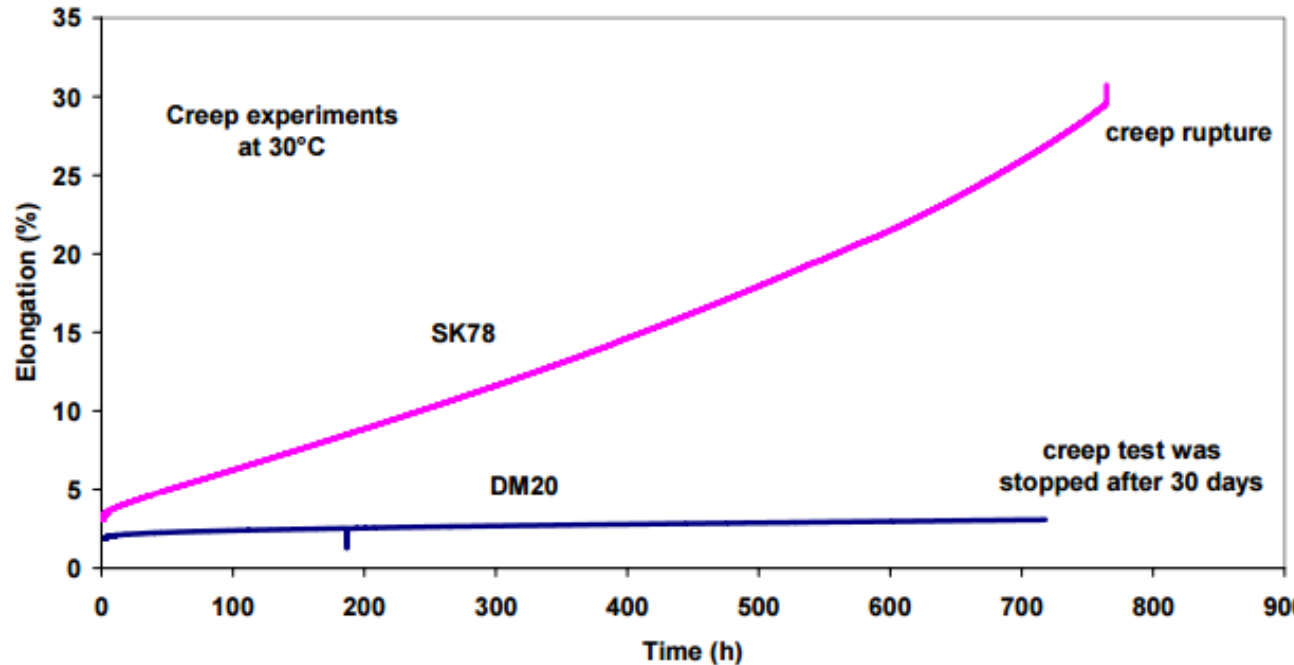
Figure 6 Creep elongation of 29 mm rope with DM20 and SK78 at 30°C

- Creep rupture occurs when a rope is under load for a long time (i.e. rope breaks).
- Creep elongation can be troublesome if precise length is needed in rope (i.e. rope grows in length)
- **EverSteel-X* contains DM20 fiber

EverSteel-X has superior creep performance making long term loading manageable and reduced likelihood of creep like failures.

Creep can contribute to line failure in long term loading scenarios.

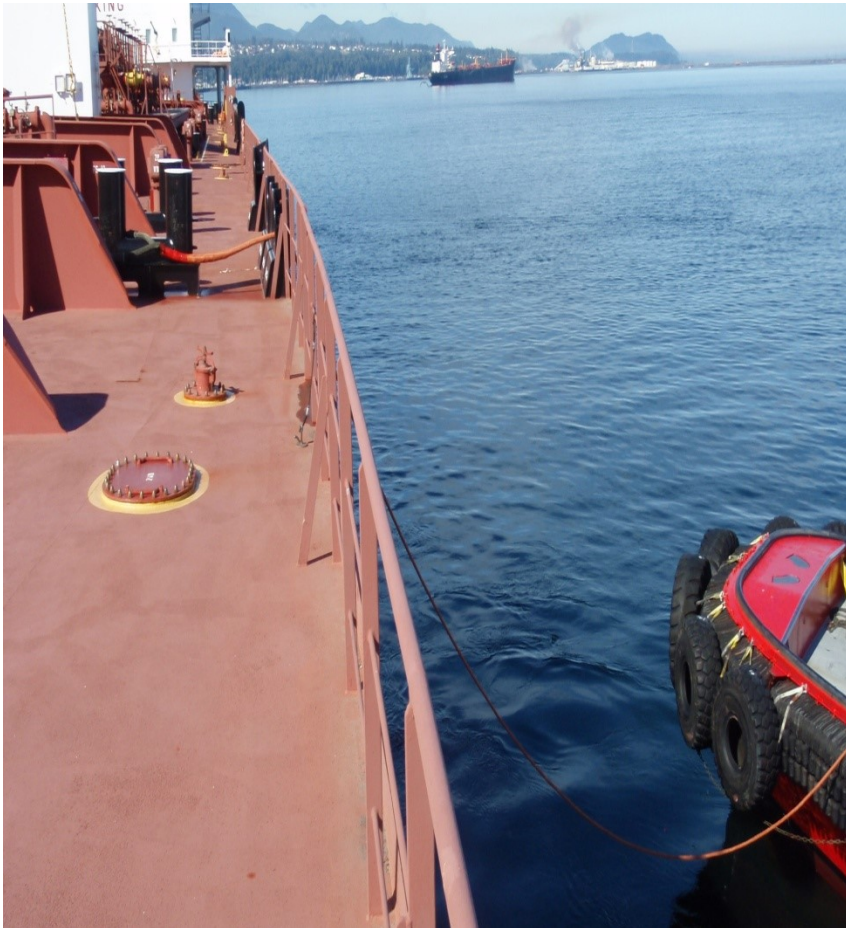
FOR INFO. VULCAN ETOPS

- World's only Fibre ETOP
- Patented design
- Nominated for Seatrade award 2015
- 60- 70% lighter than wire
- Easier to deploy and store
- Reduced injury risk
- Maintenance free
